Village of Bradley 2017 Comprehensive Flow Monitoring Final Report

Village of Bradley

SUBJECT: BRADLEY COMPREHENSIVE FLOW MONITORING – FINAL REPORT

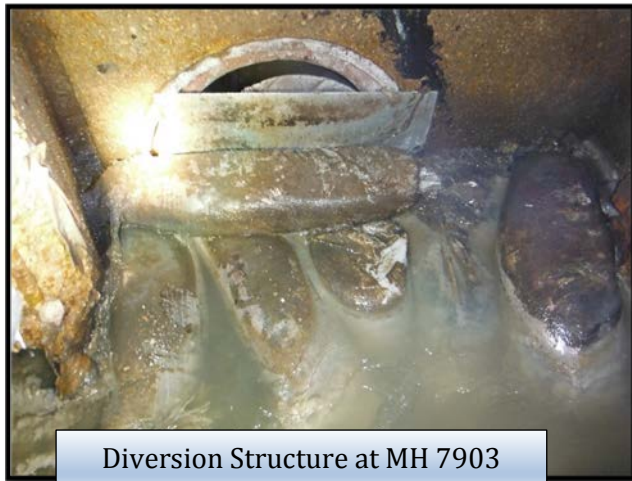
Diversion Structure at MH 7903

RJN conducted preliminary site investigations for key monitoring locations ahead of meter site selection and installations. One such site is pictured below at manhole 7903 where the diversion structure use to allow dry weather flow through town via a 21" VCP sewer, but now has been blocked off to follow the old overflow route toward the river down a 48" brick sewer as it makes its way to

the KRMA Wastewater Treatment Plant (WWTP). This structure was inspected to determine if flow was getting past the plugged pipe down the 21" line as some sinkholes have formed over the years near the Meadowview Shopping Plaza.

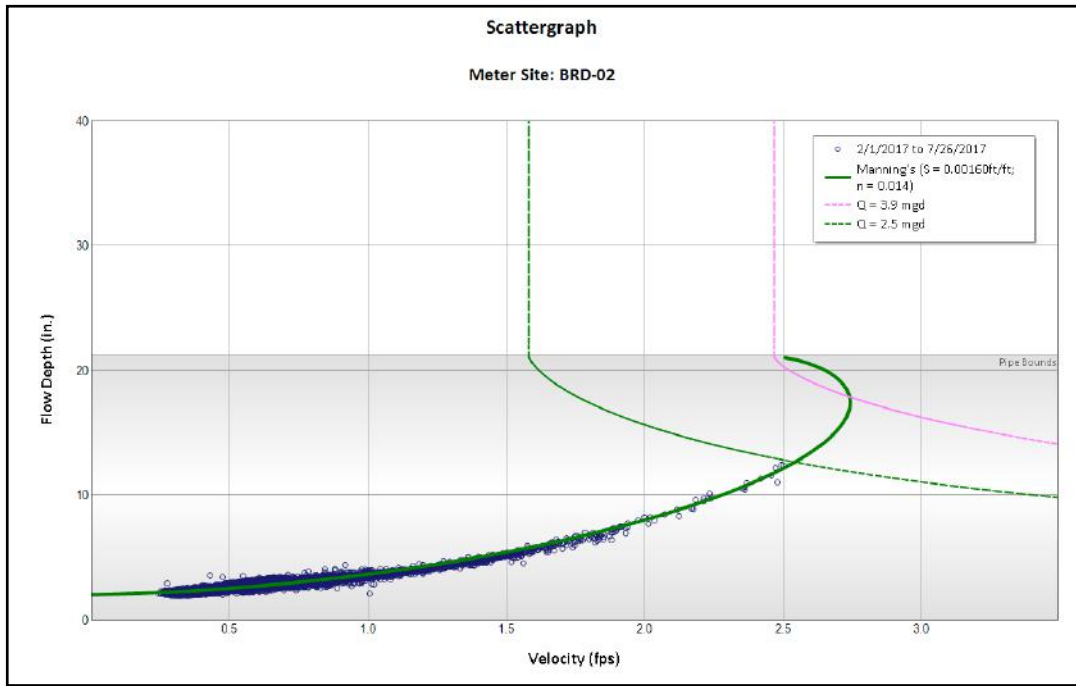
FIGURE 9
BRD-02 SCATTERGRAPH

BRD-02 showed no signs of downstream control or surcharging during the monitoring period.

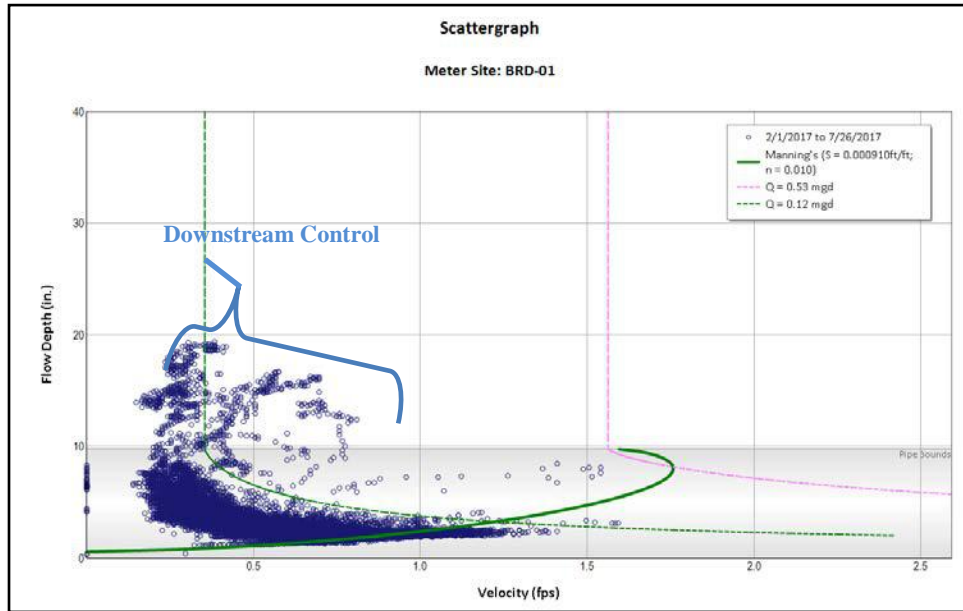
FIGURE 10
BRD-01 SCATTERGRAPH

BRD-01 displayed flow restrictions in the form of downstream control. With the full pipe capacity estimated to be 0.53 MGD, the current flow conditions allow for 23% of this flow at full pipe conditions.

BRD-01 experienced the largest amount of downstream control throughout the monitoring period. The 1-year, 1-hour storm recorded on 6-13-2017 had no downstream control, however. The downstream control occurred during the smaller storms in April and May.

Two sites experienced downstream during the monitoring period, BRD-01 & BRD 07. BRD-01 experienced surcharging during rain events, likely due to higher flows downstream coming from the junction with flows from Bourbonnais just outside the KRMA treatment plant. Another possibility is that flows are restricted at BRD-01 due to KRMA throttling the flow or closing gates to limit wet weather flows into the plant. BRD-07 showed signs of downstream control during dry weather periods, with high depths and low velocities. It is recommended to investigate this issue. Potential causes can be large amounts of debris downstream that needs to be cleaned out, or a flow restriction due to the downstream Lower Soldier Creek lift station.

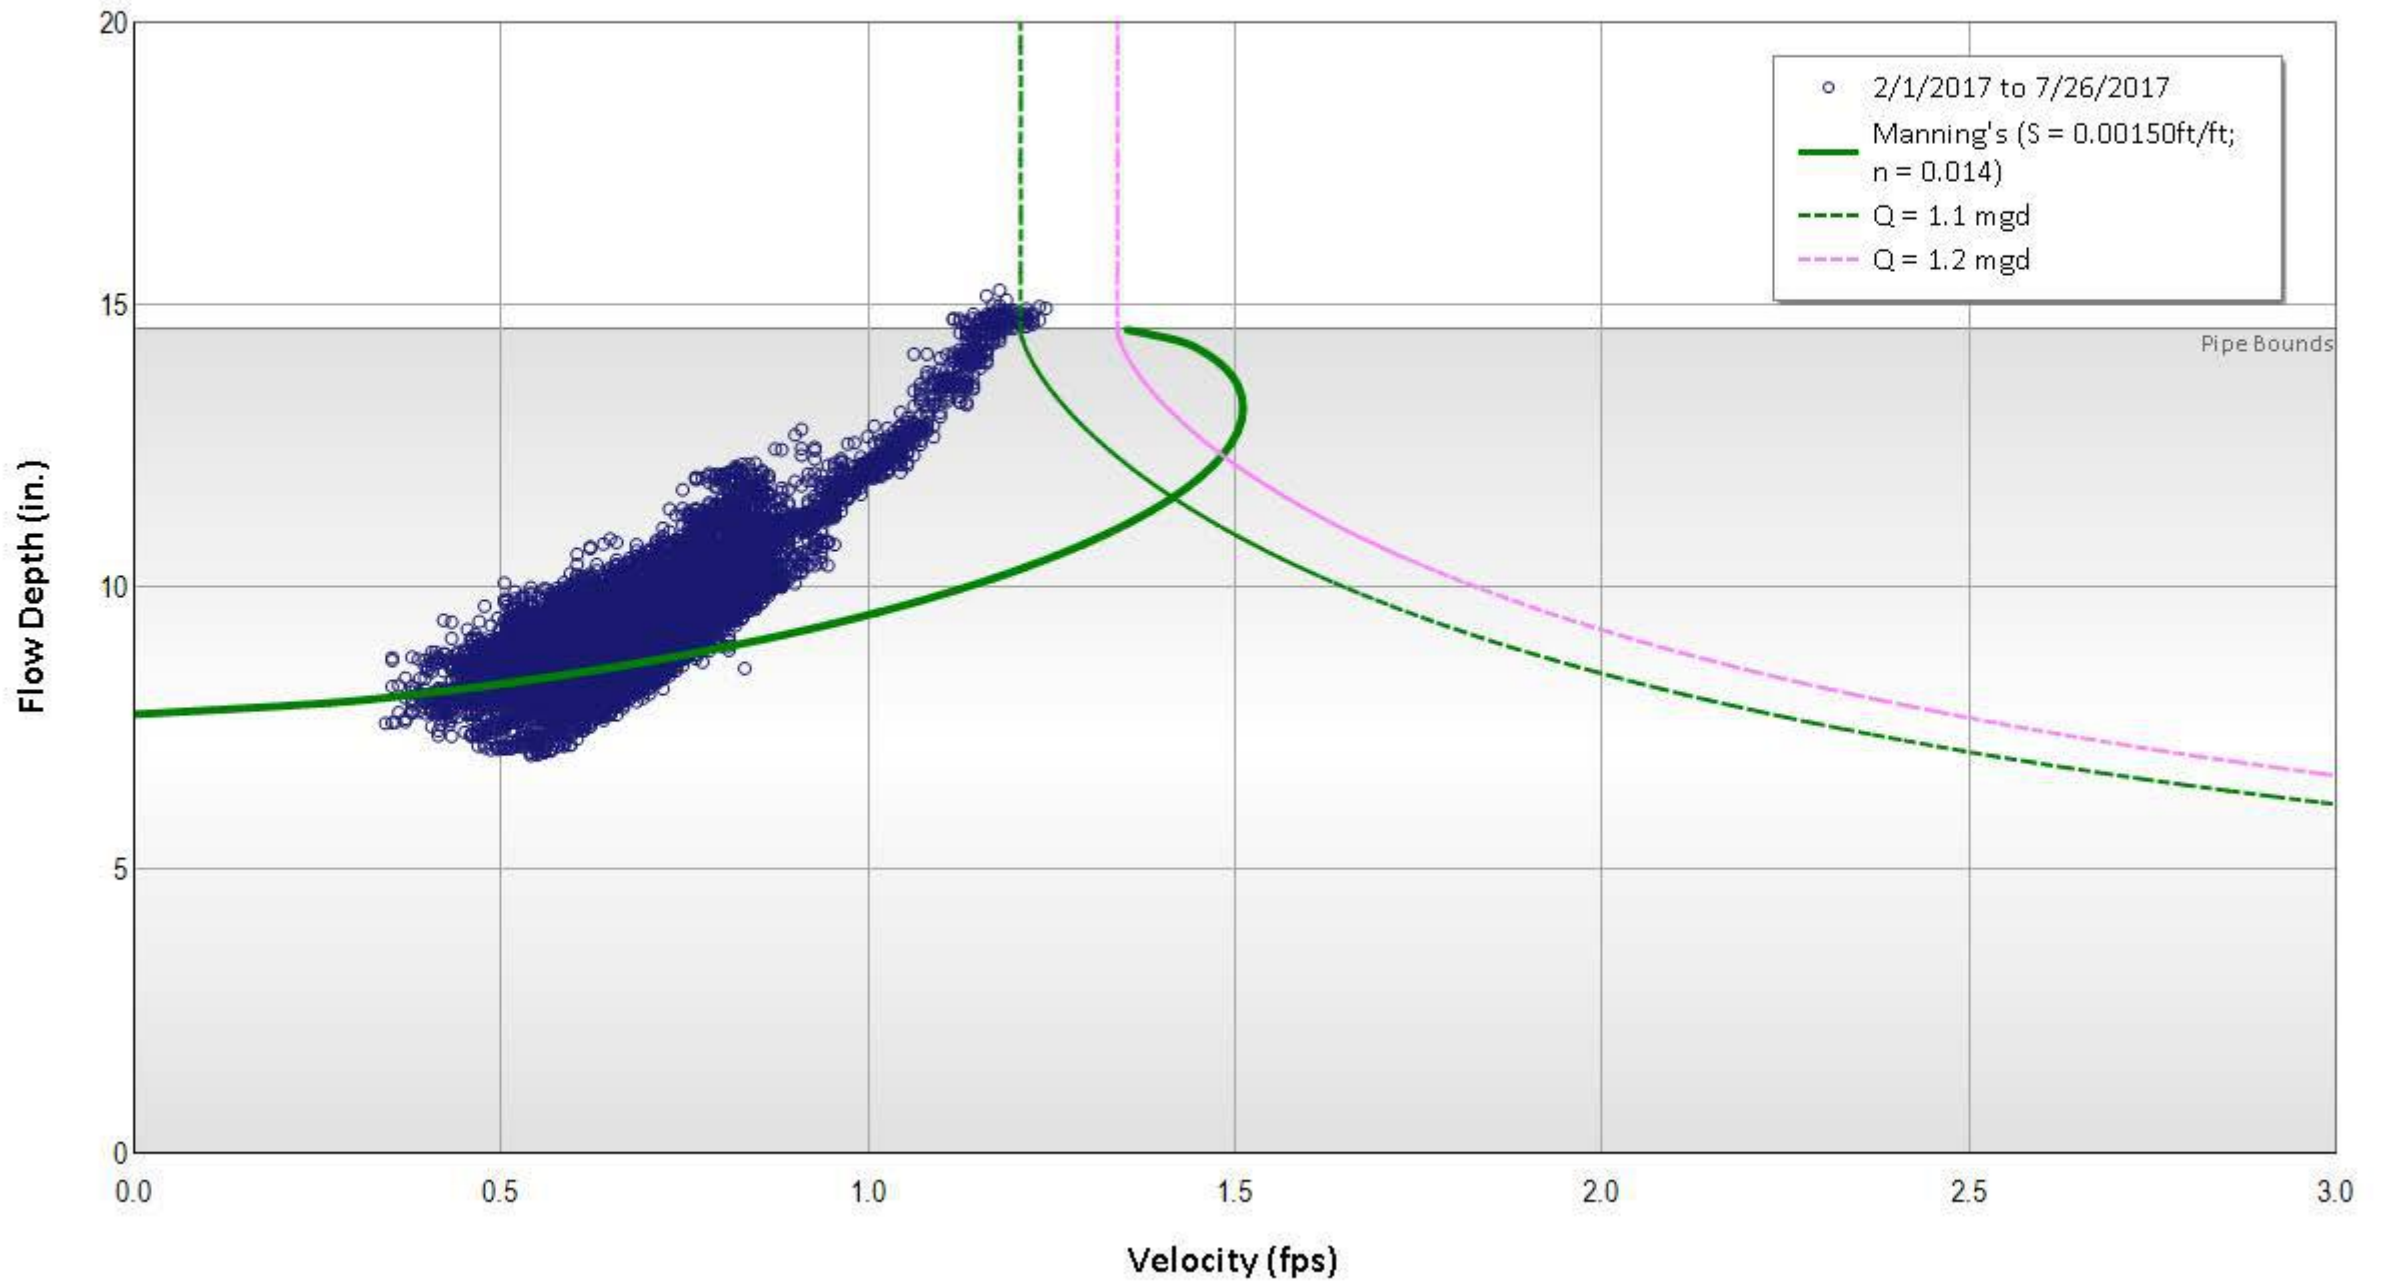
Meter Site: BRD-07

During dry weather conditions, BRD-07 consistently recorded high depths with low velocities. This is an indication of downstream control. In these conditions, debris can settle out and create more head loss, potentially causing surcharging.
