BRADLEY ILLINOIS

VILLAGE PARKS ASSESSMENT PLAN

July 26, 2021

Prepared by
Teska Associates
627 Grove Street
Evanston, IL 60201

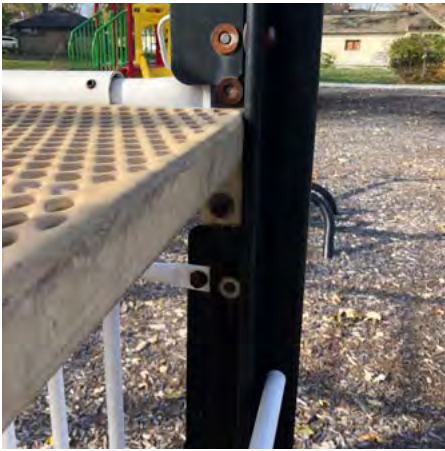
Black and White elevated component play structure has exposed and rusting fasteners

- Playground Access: no accessible route to enter play area.
 - ▶ Provide transition ramps from the concrete perimeter walkway to the mulch play surface.
- Playground safety information signage not present.
- Accessible play features: This playground appears to have been recently reconstructed, at that time the ADA requirements for minimum quantity and types for ground accessible play elements would have applied. There should be (1) additional ground level play event to meet code requirements.
- Black and white component structure has exposed and rusting fasteners that pose safety risk.
 - ▶ Recommend to remove this component structure and provide another ground level play element, such as a stand alone spinner or climber.

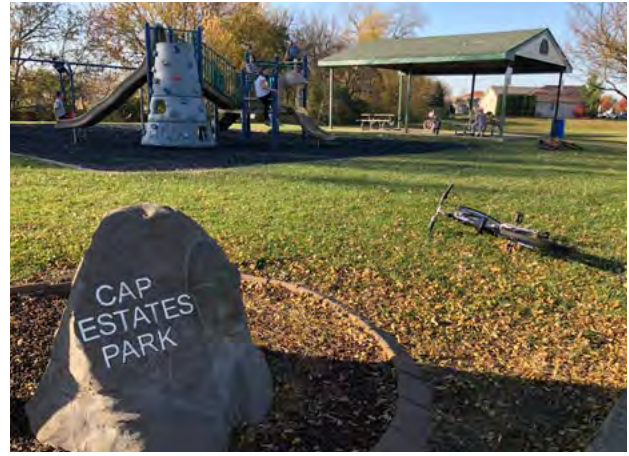
PROVIDE ACCESSIBLE ROUTE TO PLAYGROUND.
PROVIDE TRANSITION RAMP FROM PATH TO PLAY SURFACE

- Playground Access: no accessible route to enter play area.
 - ▶ Recommendation: Provide accessible route connection to playground and transition curb from path to rubber mulch play surface.

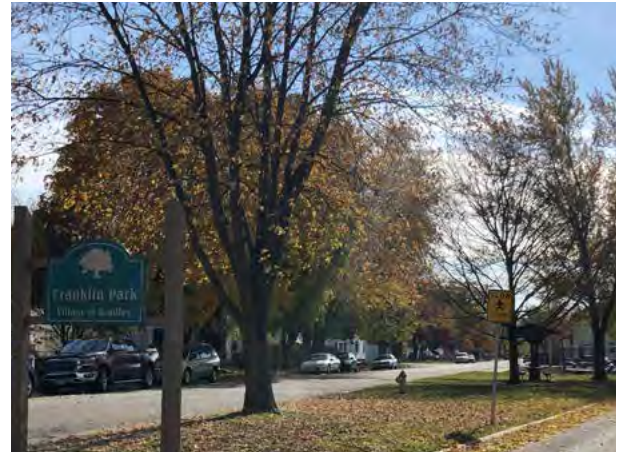
Curb ramps are not IDOT compliant a do not connect with a crosswalk

- Park Access: Franklin Park provides an accessible path around the playground. The neighborhood has a sidewalk network, but there are not IDOT compliant crosswalks connecting the park to sidewalks across the street.
- Signage: Proper signage is not posted for the blind.
 - ▶ Recommendation: provide braille signage.
- Seating: No accessible seating available.
 - ▶ Recommendation: provide accessible park benches.
- Picnic Tables: Park has 1 covered picnic table, not connected by accessible route.
 - ▶ Provide (1) accessible picnic area.

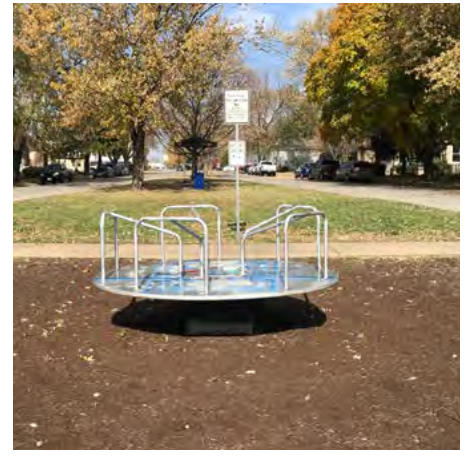
Merry-Go-Round is ground level accessible play component.

- Playground Access: no accessible route to enter play area.
 - ▶ Recommendation: Provide transition curb from path to wood mulch play surface.
- Merry-go-round does not meet safety guidelines
 - ▶ See Recommendations for MERRY-GO-ROUNDS on page 43

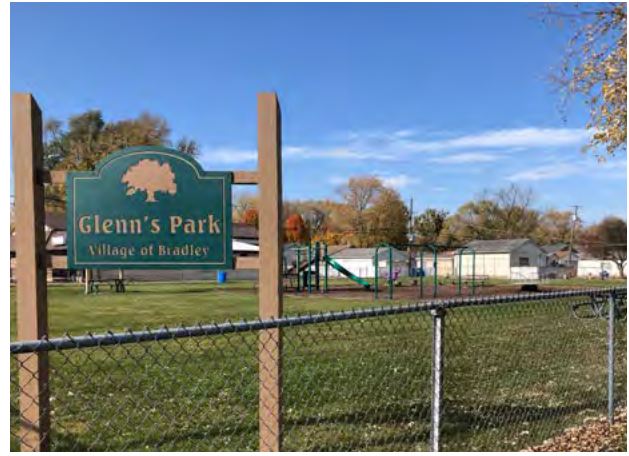
- PROVIDE ACCESSIBLE ON-STREET PARKING
- PROVIDE ACCESSIBLE PICNIC AREA
- PROVIDE ACCESSIBLE ROUTE THROUGH PARK CONNECTING PARK ENTRANCES AND AMENITIES

- Park has no interior accessible routes.
 - ▶ Recommendation: create a pathway system to connect playground and picnic table with park entrance.
- Park is not connected to a neighborhood pedestrian network. Neighborhood does not have sidewalks or crosswalks.
- Signage: Proper signage is not posted for the blind.
 - ▶ Recommendation: provide braille signage.
- Parking: on-street parking is available.
 - ▶ Recommendation: provide (1) accessible parking spot with accessible route to park amenities.
- Seating: No accessible seating available.
 - ▶ Recommendation: provide accessible park benches
- Picnic Tables: Park has 1 covered picnic table and 2 freestanding picnic tables. No tables are connected by accessible route.
 - ▶ Provide (1) accessible picnic area.

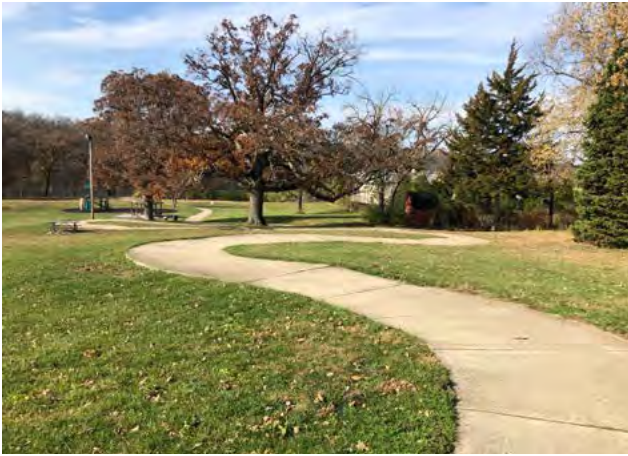
Park path follows a switch back pattern down the hill. Many sections of the path exceed 5% slope

- Universal Access: switch back path is over 5% slope in many cases, with some locations going over the maximum allowable 8%. Paths over 5% ought to be designed to the requirements of ADA ramps, including hand rails and landings. Thus the playground and the pavilion seating area are not considered accessible. Future park improvement efforts should consult with engineers to determine feasibility and associated costs for path reconstruction.
- Signage: Proper signage is not posted for the blind.
 - ▶ Recommendation: provide braille signage.
- Parking: on-street parking is available.
 - ▶ Recommendation: provide (1) accessible parking spot with accessible route to park amenities.
- Seating:
 - ▶ Recommendation provide park benches along an accessible route.

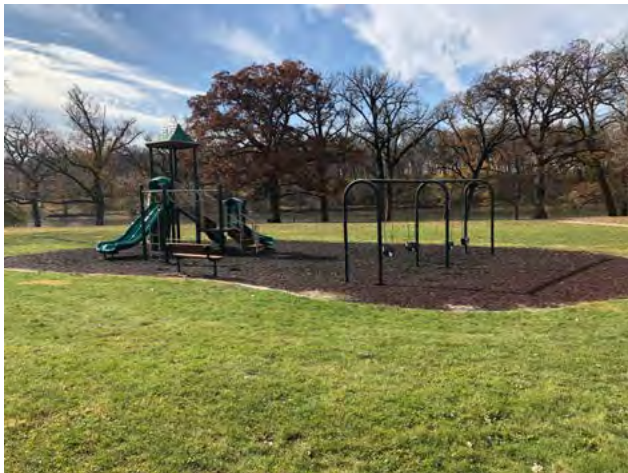
Provide an accessible route to playground

- Playground Access: no accessible route to enter play area.
 - ▶ Recommendation: Provide accessible route connection to playground and transition curb from path to rubber mulch play surface.
- Ensure that appropriate safety surface levels are maintained.

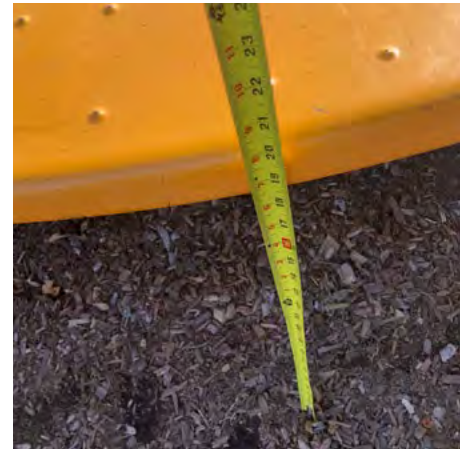
Merry-go-round does not meet safety guidelines, clear space under platform is too tall.

- Playground Access: no accessible transition to playground surface
 - ▶ Recommendation: Provide transition ramp from path to wood mulch play surface.
- Merry-go-round does not meet safety guidelines
 - ▶ See Recommendations for MERRY-GO-ROUNDS on page 43
- Purple dinosaur spring rocker does not meet safety guidelines
 - ▶ See Recommendations for DINOSAUR SPRING ROCKER on page 42

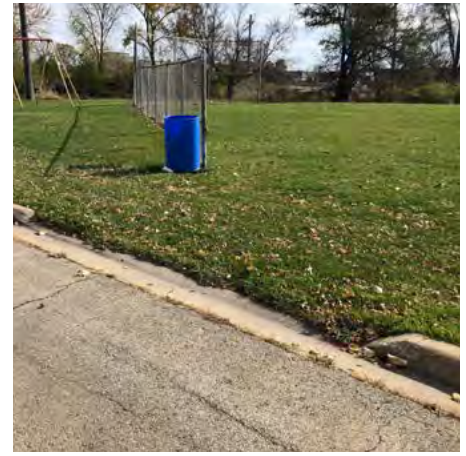
Park has no interior paths and there are no sidewalk connections

- Signage: Proper signage is not posted for the blind.
 - ▶ Recommendation: provide braille signage.
- Park has no interior accessible routes.
- Park is not connected to an accessible pedestrian network. Neighborhood does not have sidewalks or crosswalks.

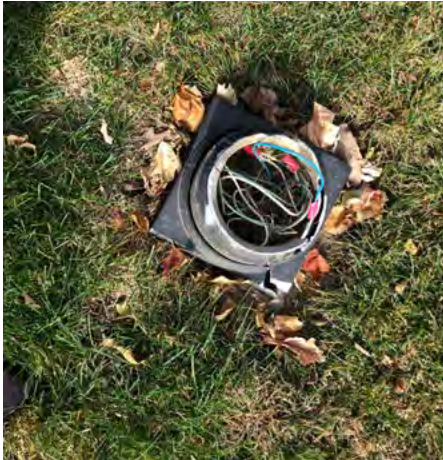
Lamp has been removed. Base and wires remain which poses a safety hazard and should be addressed

- Signage: Proper signage is not posted for the blind.
 - ▶ Recommendation: provide braille signage.
- Parking: on-street parking is available.
 - ▶ Recommendation: provide (1) accessible parking spot with accessible route to park amenities.
- Monument: Steps do not provide compliant handrails. No ramp or other means of universal access to platform.
- Park Access: Sidewalk does not provide compliant curb ramps at pedestrian crossings.
- Note: Lamp post removed, remaining base is damaged. Electrical wires capped.

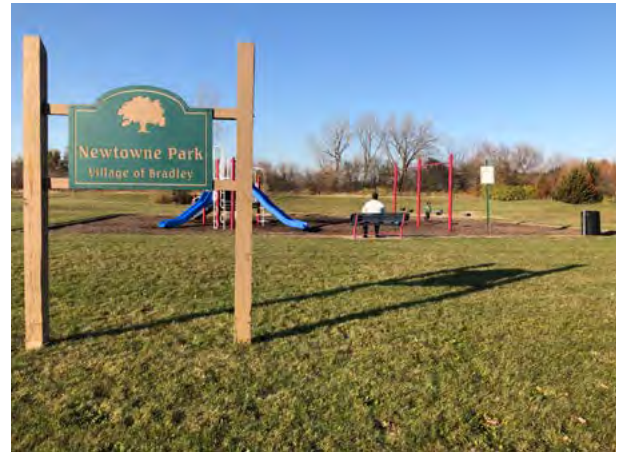
PROVIDE ACCESSIBLE ROUTE CONNECTING SIDEWALKS TO PLAYGROUND TO PLAYGROUND

PROVIDE TRANSITION RAMP FROM PATH TO PLAY SURFACE

- Park has no interior accessible routes.
 - ▶ Recommendation: create a pathway system to connect playground and picnic table with crosswalk
- Signage: Proper signage is not posted for the blind.
 - ▶ Recommendation: provide braille signage.
- Seating: No accessible seating available.
 - ▶ Recommendation: provide park benches along an accessible route

- Safety Surface is too high relative to play equipment, transfer platform should be between 11-18" above safety surface.
- Playground Access: no accessible route to enter play area.
 - ▶ Recommendation: Provide accessible route connection to playground and transition curb from path to play surface.

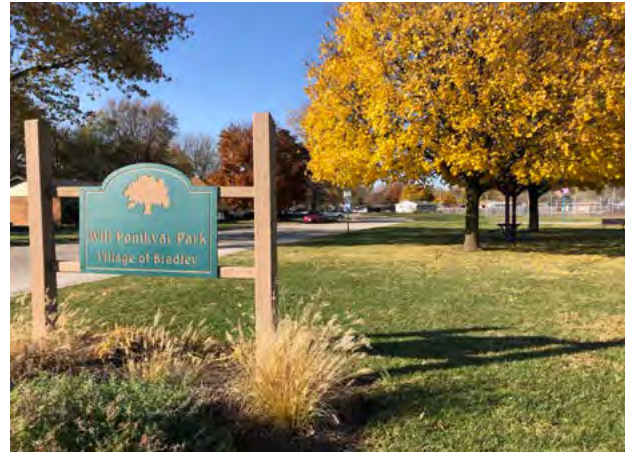
- PROVIDE TRANSITION RAMP FROM PATH TO PLAY SURFACE
- PROVIDE ACCESSIBLE ROUTE THROUGH PARK CONNECTING PARK ENTRANCES AND AMENITIES
- PROVIDE ACCESSIBLE ON-STREET PARKING

- Park has no interior accessible routes.
 - ▶ Recommendation: create a pathway system to connect playground and picnic shelter with park entrance.
- Park is not connected to a neighborhood pedestrian network. Neighborhood does not have sidewalks or crosswalks.
- Signage: Proper signage is not posted for the blind.
 - ▶ Recommendation: provide braille signage.
- Parking: on-street parking is available.
 - ▶ Recommendation: provide (1) accessible parking spot with accessible route to park amenities.
- Seating: No accessible seating available.
 - ▶ Recommendation: provide park benches along an accessible route

- Playground Access: no accessible route to enter play area.
 - ▶ Recommendation: Provide accessible route connection to playground and transition curb from path to rubber mulch play surface.
- Purple dinosaur spring rocker does not meet safety guidelines
 - ▶ See Recommendations for DINOSAUR SPRING ROCKER on page 42

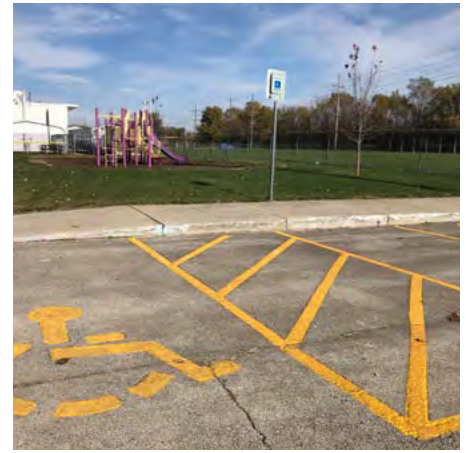
ADA parking does not meet code.

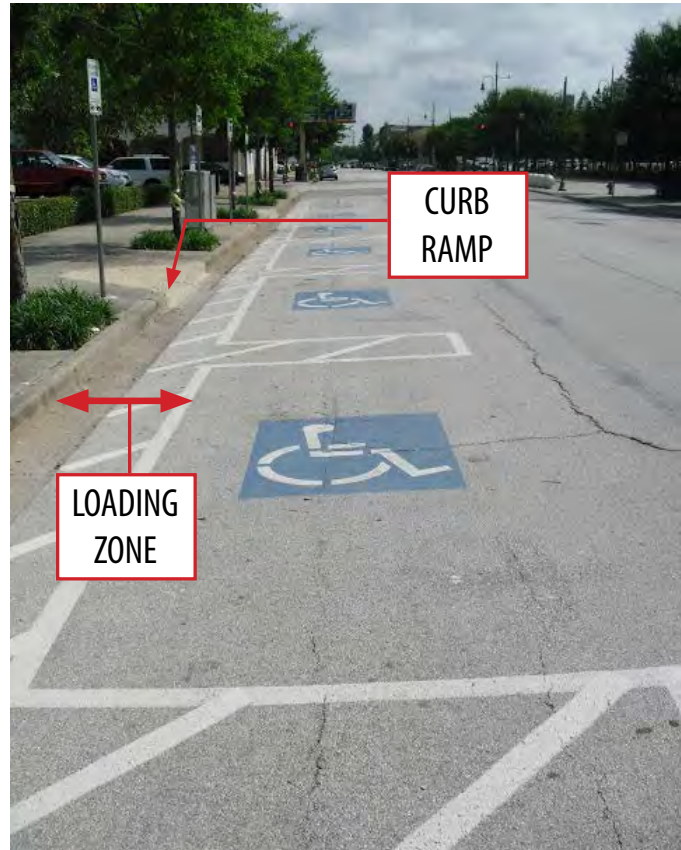
EXAMPLE OF ACCESSIBLE ON-STREET PARKING

On-street parking is available at most parks in Bradley. Where on-street parking is provided there should also be accessible on-street parking. Accessible on-street parking shall meet IDOT standards (Bureau of Design and Environment Manual- Chapter 58).

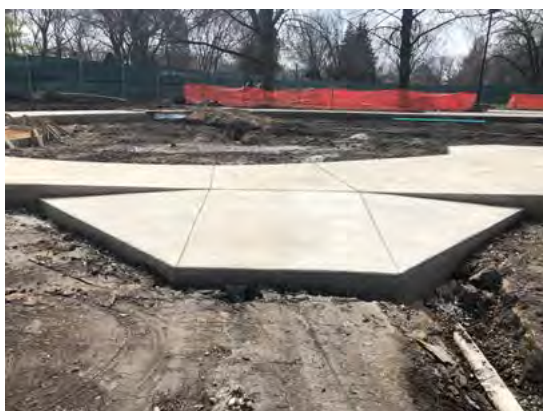
All park playgrounds in Bradley should provide a transition ramp from the accessible path to the play surface.

CONSTRUCTION PHOTO SHOWING A CONCRETE TRANSITION RAMP BEFORE THE SAFETY SURFACE HAS BEEN INSTALLED.
