Village of Bradley 2017 Comprehensive Flow Monitoring Final Report

Village of Bradley

SUBJECT: BRADLEY COMPREHENSIVE FLOW MONITORING – FINAL REPORT

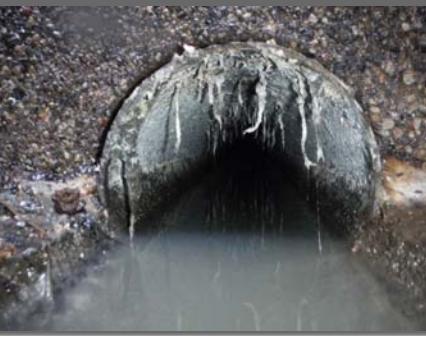
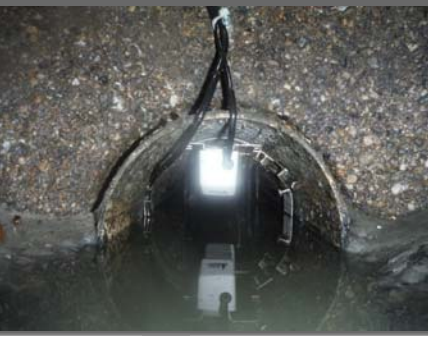
Pipe Height (in)	9.81	Next to flume	
Pipe Width (in)	9.81		
Pipe Type	Polyvinyl Chloride	Investigation Photo	
Pipe Shape	Circular

O2	20.9		
LEL %	0.0		
H2S	0.0		
CO	0.0		
Hydraulic Information			Installation Photo
Flow Depth (in)	3.00

Instant Velocity (fps)	0.55		
Surcharge Evidence (ft)	6.00		
Silt Type	None		
Silt Depth (in)	0.00		
Needs Cleaning	No		
Backwater	Yes		
Flow Path	Straight		
Drop Inlet	No		
Hydraulic Rating	Fair		
Installation Notes		Hydraulic Characteristics	
Location in Pipe (ft)	0.7		
Location from Manhole	Upstream	Install Plan Sketch	
Sensors	Pressure, Velocity, and Ultra

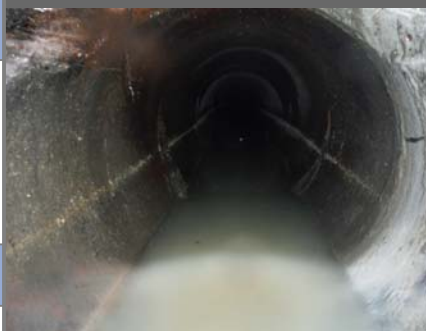
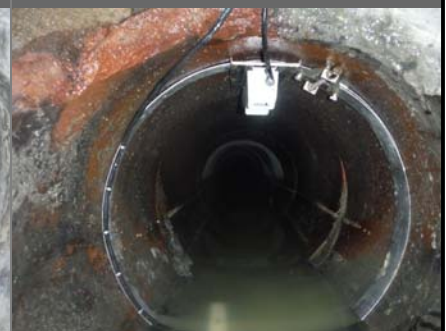
Flow Depth (in) 3.00
 Instant Velocity (fps) 0.72
 Surge Evidence (ft) 7.00
 Silt Type None
 Silt Depth (in) 0.00
 Needs Cleaning No
 Backwater No
 Flow Path Straight
 Drop Inlet No
 Hydraulic Rating Good

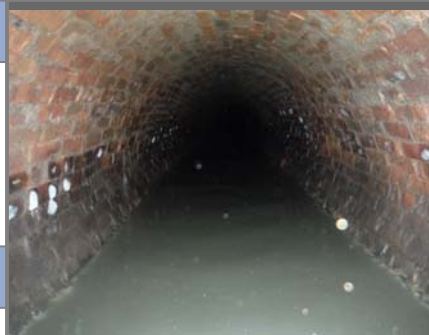
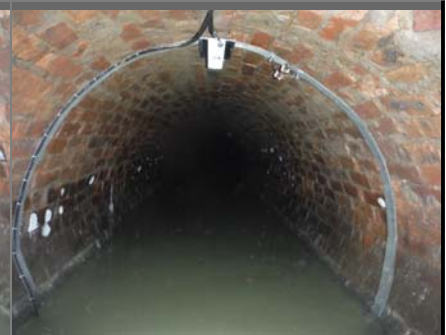
Flow Depth (in) 13.75
 Instant Velocity (fps) 1.70
 Surge Evidence (ft)
 Silt Type None
 Silt Depth (in) 0.00
 Needs Cleaning No
 Backwater No
 Flow Path Straight
 Drop Inlet No
 Hydraulic Rating Good

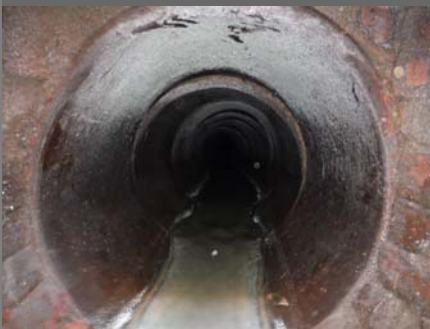
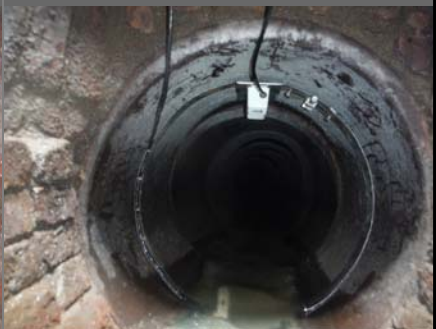
Hydraulic Information		Hydraulic Characteristics		Installation Notes
Flow Depth (in) 1.00 Instant Velocity (fps) 2.40 Surge Evidence (ft) Silt Type None Silt Depth (in) 0.00 Needs Cleaning No Backwater No Flow Path Straight Drop Inlet No Hydraulic Rating Good		Install Plan Sketch		Install Cross-Section Sketch
Installation Notes

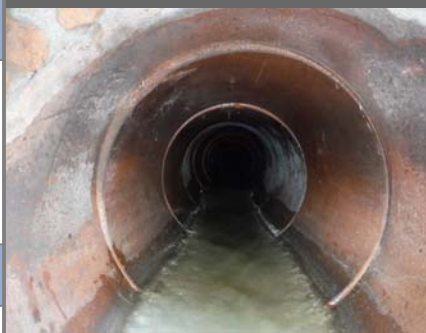
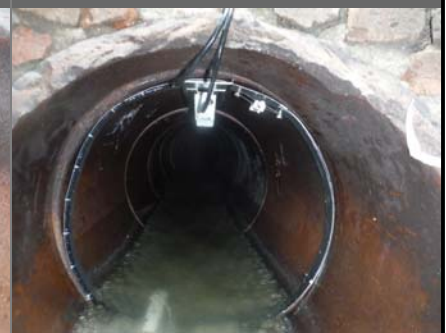
Flow Depth (in) 3.00
 Instant Velocity (fps) 3.37
 Surge Evidence (ft)
 Silt Type None
 Silt Depth (in) 0.00
 Needs Cleaning No
 Backwater No
 Flow Path Straight
 Drop Inlet No
 Hydraulic Rating Good

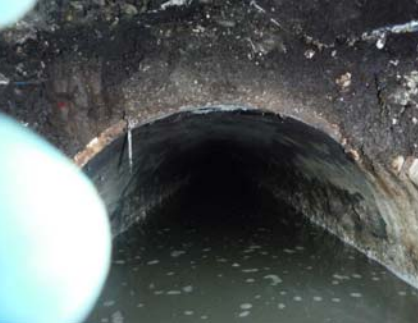
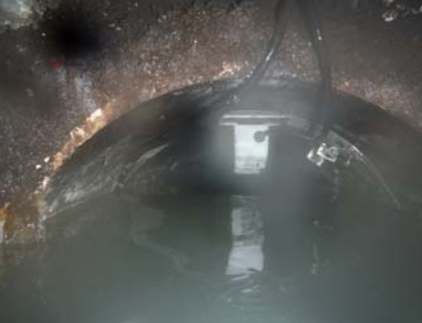
Site Information Pipe Height (in) 14.56 Pipe Width (in) 17.75 Pipe Type Other Pipe Shape Elliptical O2 20.9 LEL % 0.0 H2S 0.0 CO 0.0	Investigation Photo

Hydraulic Information Flow Depth (in) 9.00 Instant Velocity (fps) 0.75 Surge Evidence (ft) Silt Type None Silt Depth (in) 0.00 Needs Cleaning No Backwater No Flow Path Straight Drop Inlet No Hydraulic Rating Fair	Hydraulic Characteristics	Installation Notes
Installation Notes Location in Pipe (ft) 1.0 Location from Manhole Upstream Sensors Pressure, Velocity, and Ultra Antenna Surface Paved Surface Signal Strength 100	Install Plan Sketch

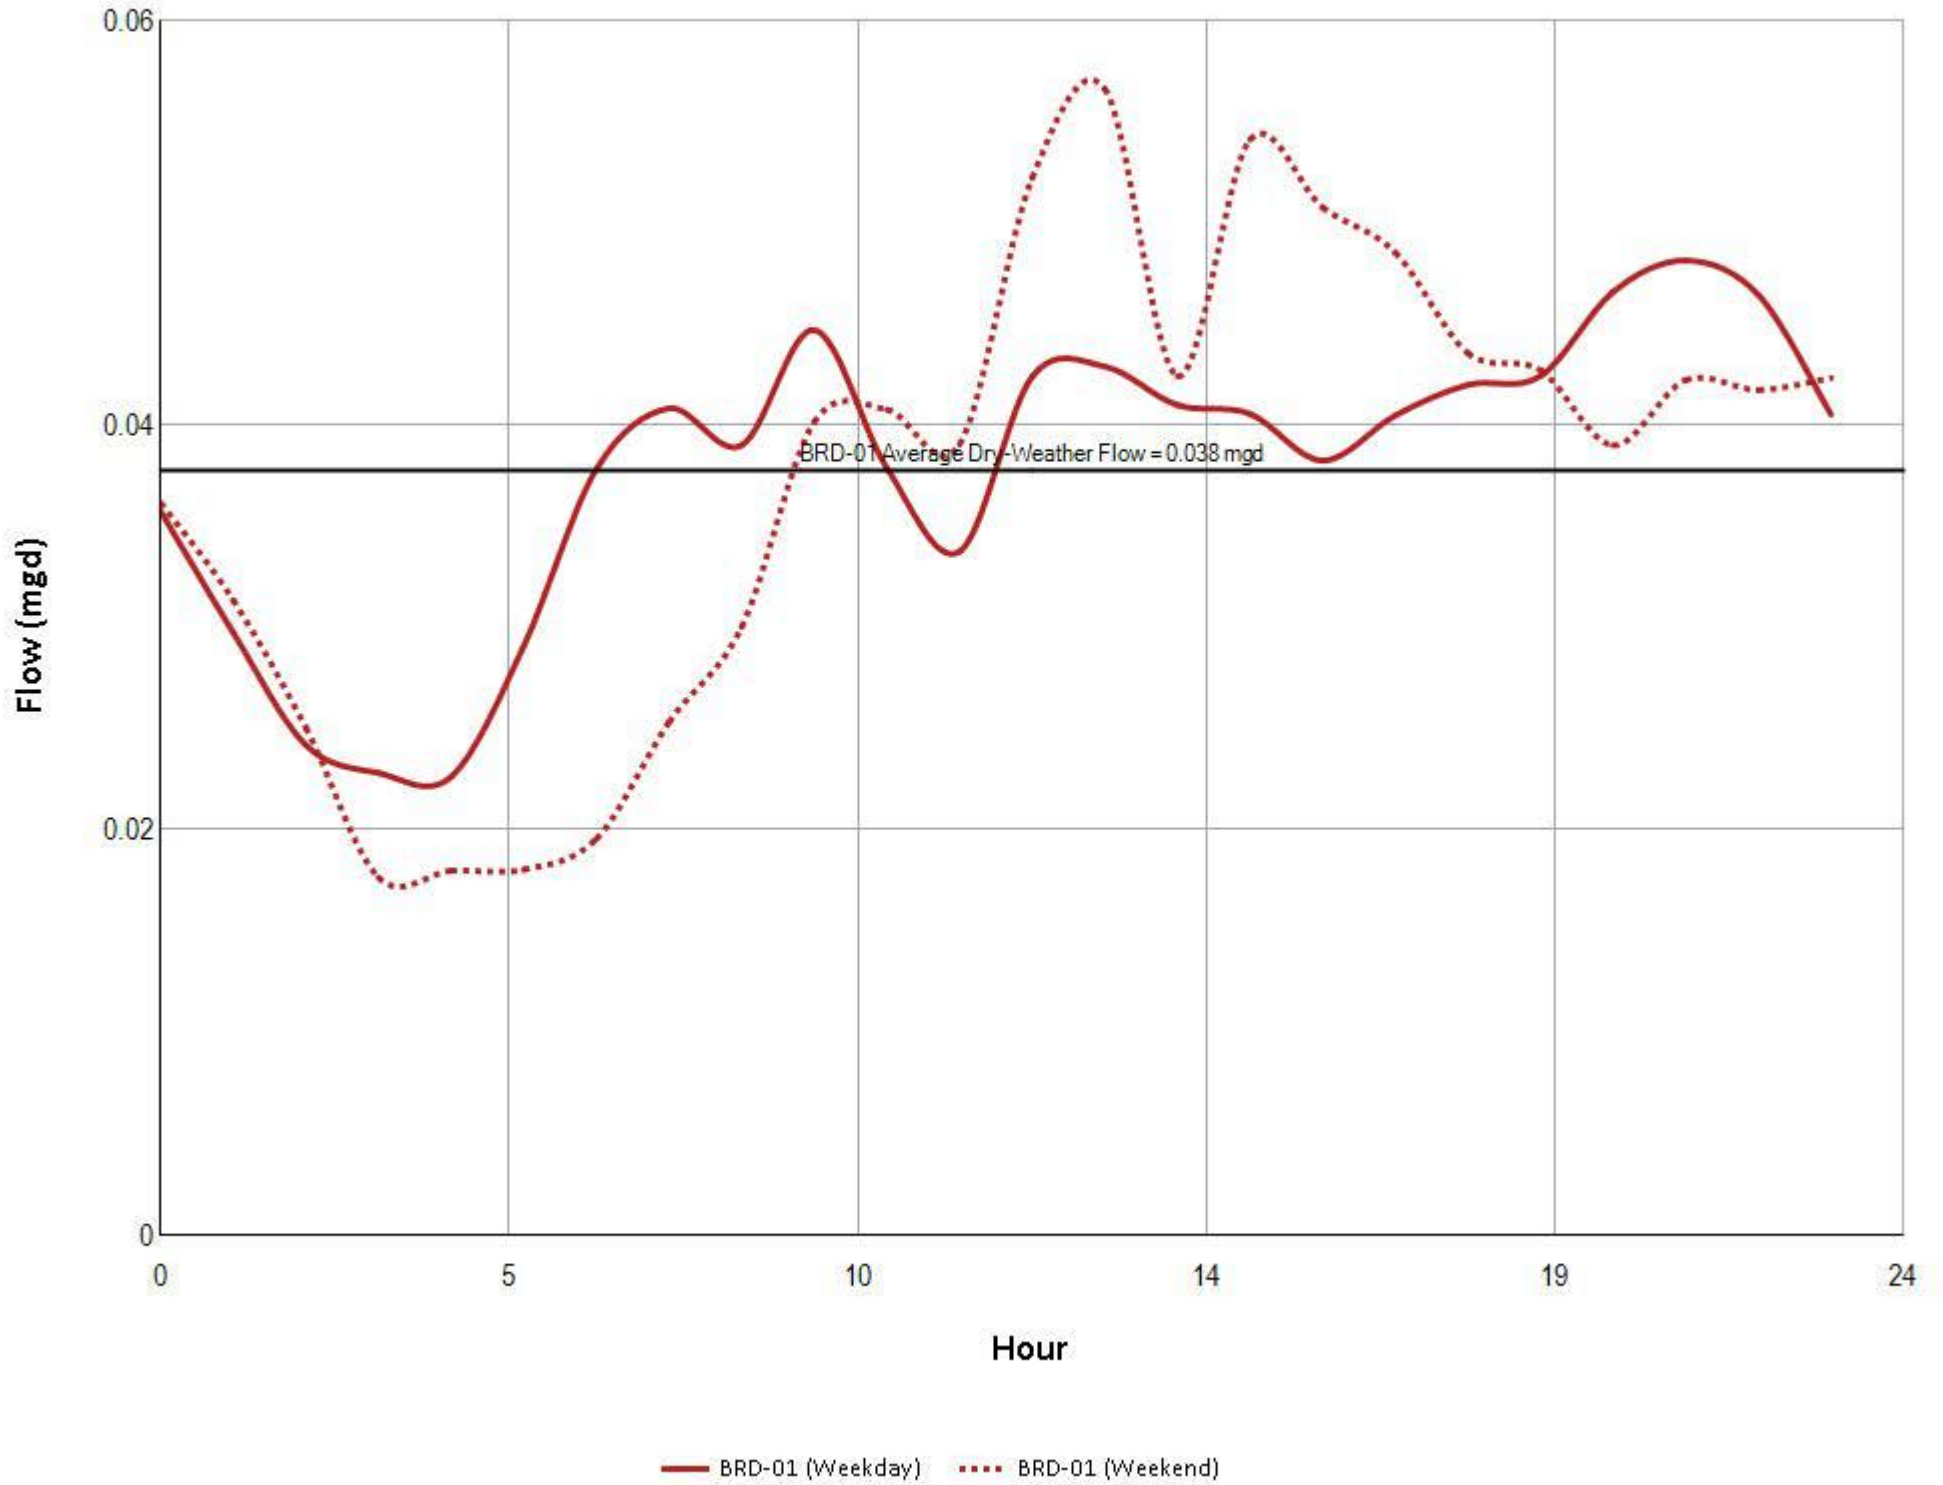
Site: BRD-01 - Average Dry-Weather Flow

BRD-01 displayed flow restrictions in the form of downstream control. With the full pipe capacity estimated to be 0.53 MGD, the current flow conditions allow for 23% of this flow at full pipe conditions.

Two sites experienced downstream during the monitoring period, BRD-01 & BRD 07. BRD-01 experienced surcharging during rain events, likely due to higher flows downstream coming from the junction with flows from Bourbonnais just outside the KRMA treatment plant. Another possibility is that flows are restricted at BRD-01 due to KRMA throttling the flow or closing gates to limit wet weather flows into the plant. BRD-07 showed signs of downstream control during dry weather periods, with high depths and low velocities. It is recommended to investigate this issue. Potential causes can be large amounts of debris downstream that needs to be cleaned out, or a flow restriction due to the downstream Lower Soldier Creek lift station.
